**Flood Control Project Maintenance
Levee Inspections**

Fall 2016 Levee Maintenance Deficiency Summary Report

**Flood Control Project Maintenance
Levee Inspections**
LMA District Cover Sheet
Fall 2016 Levee Inspection Results

Marysville Levee Commission

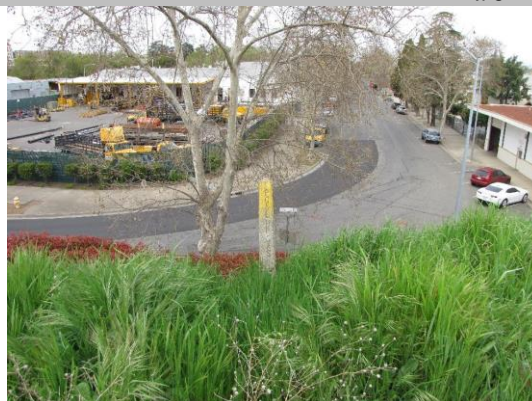
Photo 1 of 2 : UCIP_FA_2016_49944_72686.jpg

LM Start	0.48	Rating **	M	Issue No.	61 (cont)
LM End	0.48	Issue Type +	En	Location *	WS

View of LS.

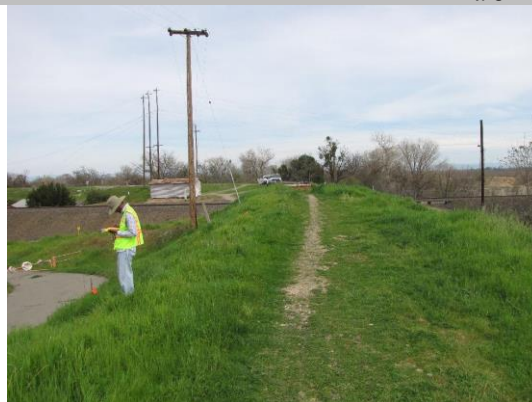
Photo 2 of 2 : UCIP_FA_2016_49945_72700.jpg

Comment Code					
Inspector Comment					
FS_ID:49945 DS_ID:25058 EP_NO: N/A Repair Type: Non-Urgent Crossing Status: Indicator Found UCIP Comments: 6/30/2016 Coordinating with USACE to obtain details of crossing obtained during the planning phase of the Slurry Wall project. (DWR UCIP - omagana)6/29/2016 PG&E marker found on LS. Marker plate found on the LS ramp. No marker was found on the WS. (DWR UCIP - omagana)1/1/2014 Frank Miller Superintendent Marysville Levee Commission.To whom it may concern, Marysville Levee Commission is in process of drafting a letter to determine line owner as well as line status, wether active or non-active as well as cordinates. (LMA Superintendent - fmiller)3/14/2013 Unable to confirm if marker is for new line or if marker is for crossing immediately upstream of this marker. (DWR UCIP - omagana) FIELD_STRUCT_DESC: 8-inch steel line through the levee at an unknown depth. Underground service alert (USA) flags are visible on the landside (LS). Points recorded for this line include 39.1363869999, -121.584067444; 39.136348328, -121.584171185. FS Date: 6/29/2016

LM Start	0.55	Rating **	M	Issue No.	62 (cont)
LM End	0.55	Issue Type +	En	Location *	WS

View of levee crown.

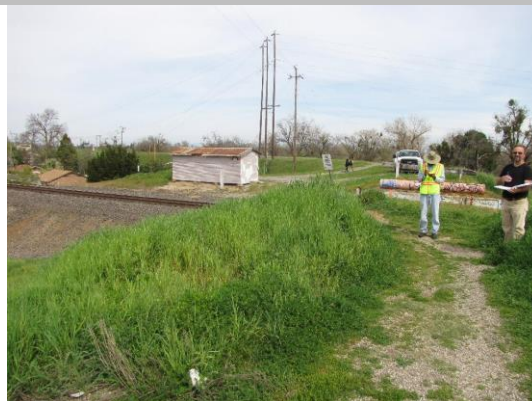
Photo 2 of 2 : UCIP_FA_2016_49947_72689.jpg

FS_ID:49947
DS_ID:19135
EP_NO: 3823
Repair Type: Non-Urgent
Crossing Status: Indicator Found
UCIP Comments: 6/29/2016 Marker found on LS slope. Marker on WS shoulder has been removed (vandalism). 1/1/2014 Frank Miller Superintendent Marysville Levee Commission. (DWR UCIP - omagana)To whom it may concern, Marysville Levee Commission is in process of drafting a letter to South Pacific Pipe Lines Inc. to determine line status, whether active non-active, as well as coordinates. (LMA Superintendent - fmiller)3/14/2016 Need to contact owner to determine status of crossing. Need date of last inspection and confirmation that crossing is still in operable condition. Multiple indicators of gas lines unable to confirm if this crossing is the line referenced in desk study--Need to contact owner. (DWR UCIP - omagana)
FIELD_STRUCT_DESC: 8.625-inch steel petroleum line sleeved through 12 inch, then 30 inch line, annular gaps grouted, 3 feet below crown. Standard metal cutoff wall around pipe in line with shoulder. Line extends beyond levee on both waterside (WS) and landside (LS). (8.625-inch line installed under Permit No. 3823, 1962 - Southern Pacific Pipelines Inc.; name change completed under Permit No. 3823-1, 2013 - SFPP, LP operates as a subsidiary of Kinder Morgan, Inc.)

View of upstream levee.

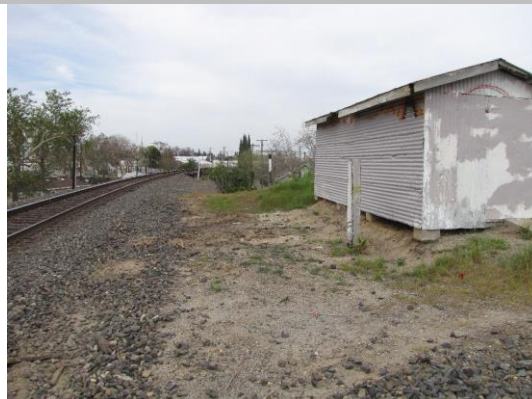
Photo 1 of 2 : UCIP_FA_2016_40975_72696.jpg

FS_ID:40975
DS_ID:25059
EP_NO: N/A
Repair Type: Non-Urgent
Crossing Status: Indicator Found
UCIP Comments: Need to coordinate with owner to determine status of crossing, details of crossing (install date and pipe size) and CVFPB permit number issued.
FIELD_STRUCT_DESC: Communication line marker found near levee crown.
FS Date: 3/14/2013

LM Start	0.58	Rating **	M	Issue No.	57 (cont)
LM End	0.58	Issue Type +	En	Location *	WS

View of landward side.

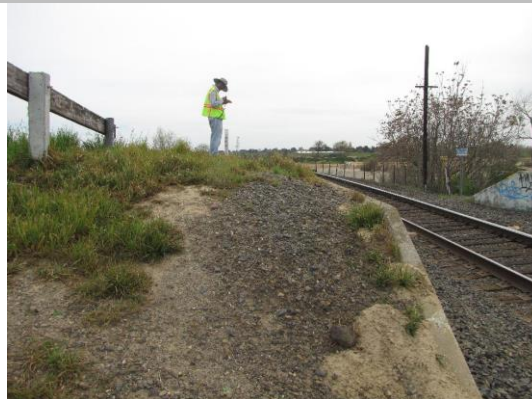
Photo 2 of 2 : UCIP_FA_2016_40975_72695.jpg

View of landward side.

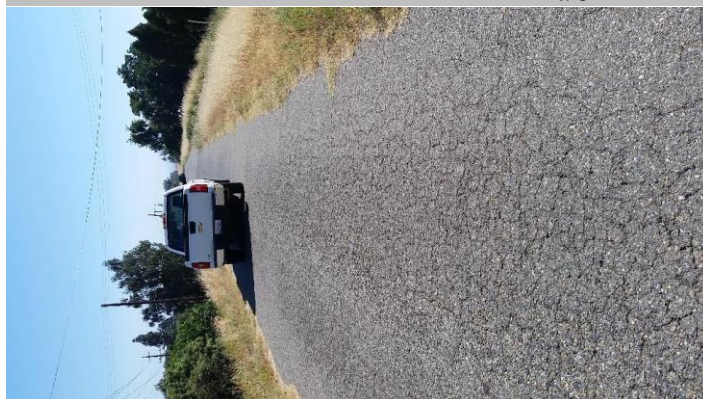
Photo 1 of 2 : UCIP_FA_2016_49951_75777.jpg

LM Start	1.59	Rating **	M	Issue No.	66
LM End	1.59	Issue Type +	En	Location *	WS
Category	Supplemental			GPS Latitude/Longitude	
				Start	End
Item	DWR UCIP Field Study			39.148891 °	39.148891 °
				-121.577420 °	-121.577420 °
DWR ID					
Comment Code					
Inspector Comment					
FS_ID:49951					
DS_ID:25468					
EP_NO: N/A					
Repair Type: Non-Urgent					
Crossing Status: Indicator Found					
UCIP Comments: 6/29/2016 Underground Service Alert (USA)					
markings visible on levee crown. Unable to determine pipe size, depth					
below crown, or permit authorizing line. Need to find owner and obtain					
status of crossing. (DWR UCIP - omagana)					
FIELD_STRUCT_DESC: Sewer line through the levee at an unknown					
depth.					
FS Date: 6/29/2016

LM Start	1.59	Rating **	M	Issue No.	66 (cont)
LM End	1.59	Issue Type +	En	Location *	WS

View of levee crown at crossing.

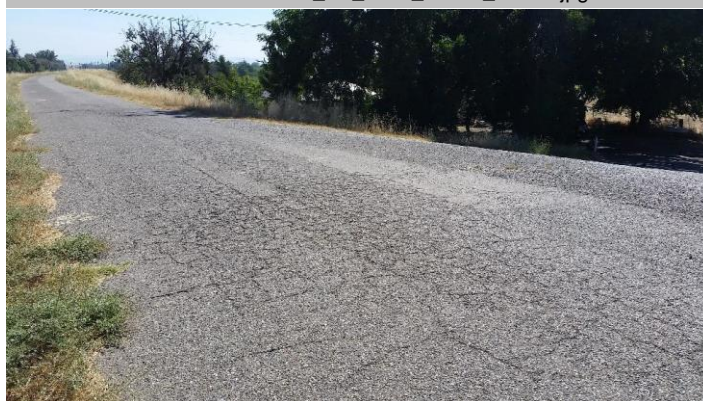
Photo 1 of 2 : UCIP_FA_2016_49952_75457.jpg

LM Start	1.65	Rating **	M	Issue No.	67 (cont)
LM End	1.65	Issue Type +	En	Location *	LS

View of levee crown.

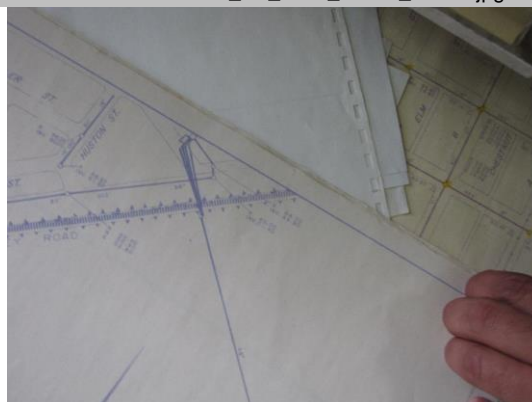
Photo 1 of 2 : UCIP_FA_2016_40998_69835.jpg

Comment Code					
Inspector Comment					
FS_ID:40998 DS_ID:19160 EP_NO: 2149 Repair Type: Non-Urgent Crossing Status: Indicator Found UCIP Comments: Depression observed on waterward toe filled with concrete rubble and riprap. Need to coordinate with City to determine records and extent of modifications if any. FIELD_STRUCT_DESC: 2 of 4: 17th & Howell Pump Station. 10-inch steel drain pipe, buried 15-feet below the crown. Runs parallel to other drainpipes, encased in concrete approx. 1-foot spacing. Pipe extends from storm water pump house to manhole (259 feet) north of landward toe. Flap gates and vent pipes at waterward toe. Discharges into concrete distribution box (3x4 foot). (Permit No. 2149-1956). FS Date: 3/14/2013

As-builts provided by Marysville Water Treatment.

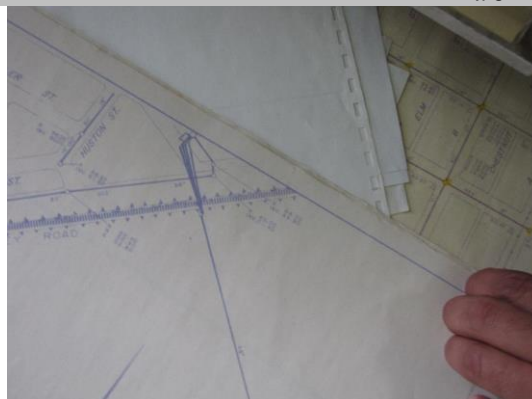
Photo 1 of 2 : UCIP_FA_2016_41001_69821.jpg

LM Start	2.18	Rating **	M	Issue No.	50 (cont)
LM End	2.18	Issue Type +	En	Location *	LS

City of Marysville Wastewater Treatment Facility records indicating multiple crossings through levee.

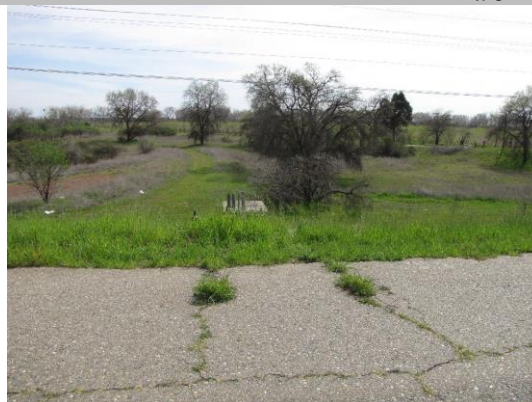
Photo 2 of 2 : UCIP_FA_2016_41001_69826.jpg

View of waterward side.
